# Commercial Roof Inspection Report

**Property Address:** 1234 Main Street Metairie, LA 70001

**Report Number:** PIM-C-2026-0001      **Inspection Purpose:** Roof Condition Assessment

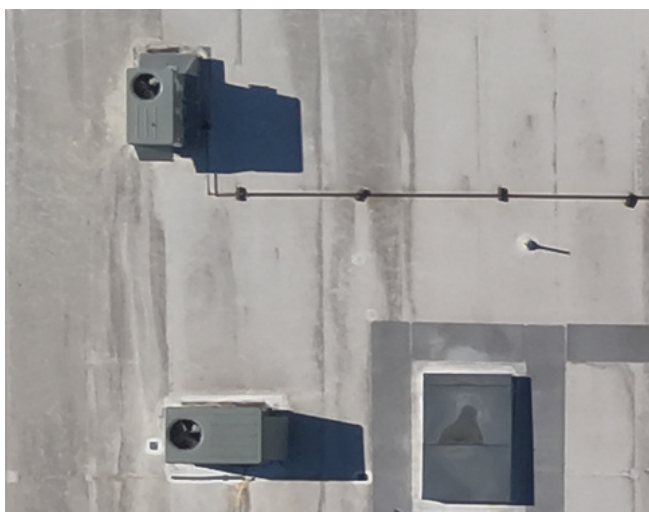
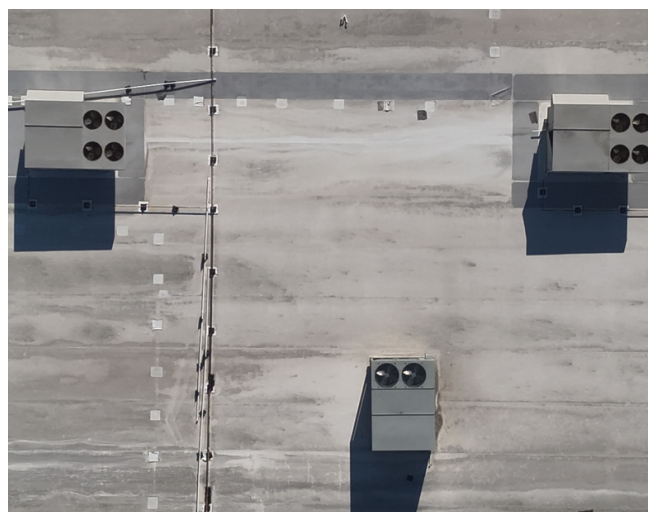
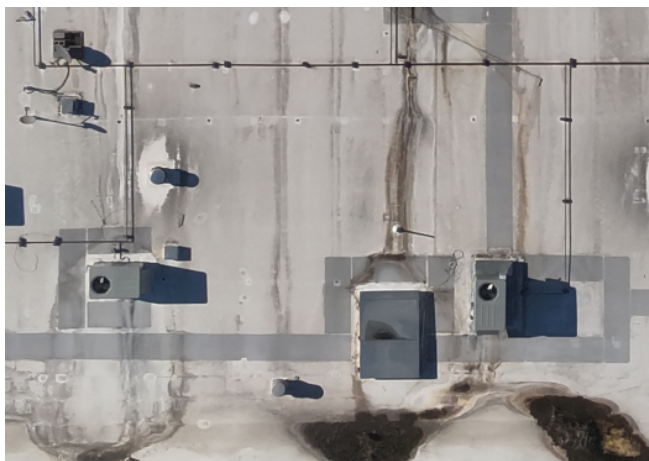
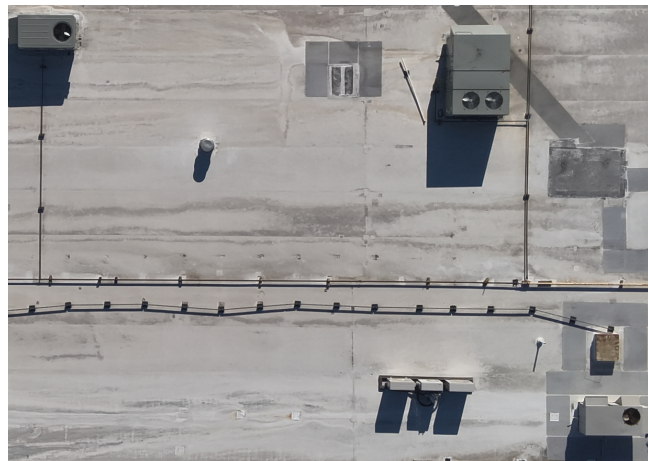
Continue routine roof maintenance and periodic inspections. Localized roof surface staining and weathering were observed in portions of the inspected area. While the cause could not be determined during this aerial visual inspection, continued monitoring and evaluation by a qualified roofing contractor is recommended if conditions worsen or signs of moisture intrusion become evident.
