# Roof Inspection Report

**Property Address:** 3630 Baker Drive Houma, LA

**Report Number:** PIM-2026-0001 **Inspection Purpose:** Roof Condition Assessment

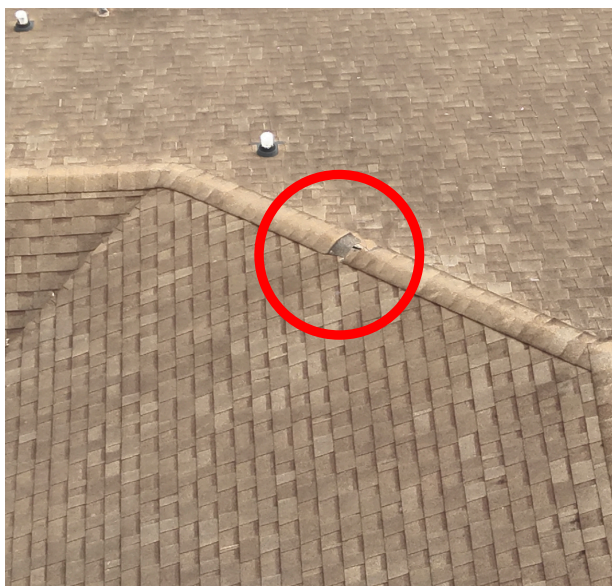
The following photographs document the visible roof surface. An area where roofing shingles appear to be absent was observed during the aerial inspection. No determination is made regarding the cause or extent beyond what is visible in the images

*Overall View of Missing Shingle Area*

Review the documented area with a qualified roofing contractor if the client desires further evaluation of the observed condition.

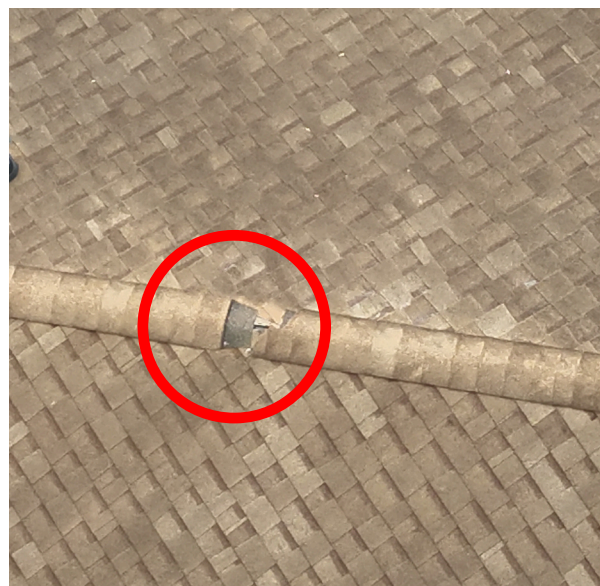
*Close-Up of Missing Shingle Area*

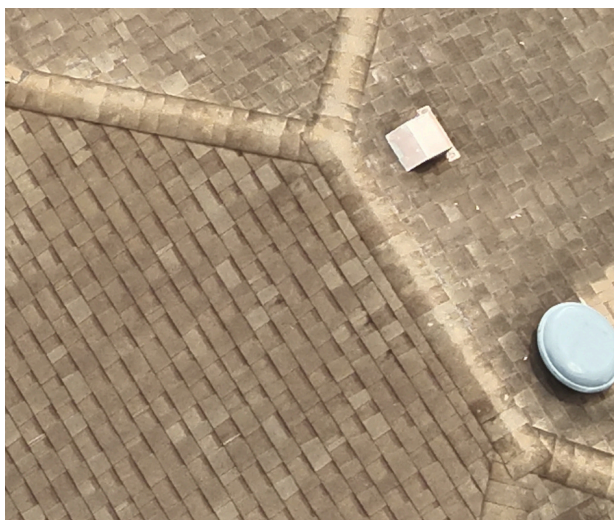
*Plumbing Vent & Roof Surface*

No additional follow-up is recommended for the roof components documented in this section based on the visible conditions observed during the aerial inspection.

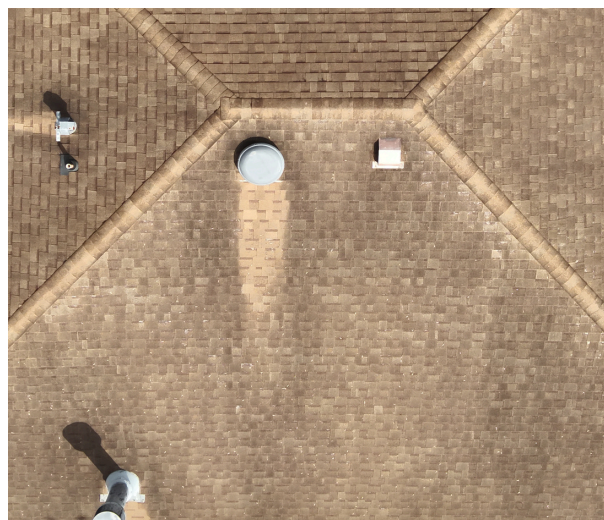
*Roof Vent & Ridge Area*
