# Roof Inspection Report

**Property Address:** 1234 Main Street Houma, LA

**Report Number:** PIM-2026-0001 **Inspection Purpose:** Roof Condition Assessment

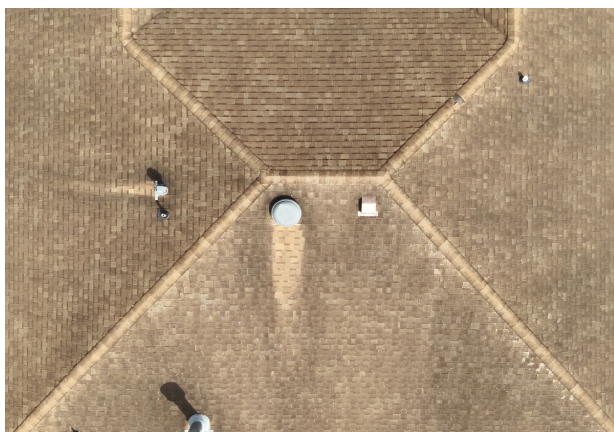
*Overall Roof Layout (Nadir 90°)*

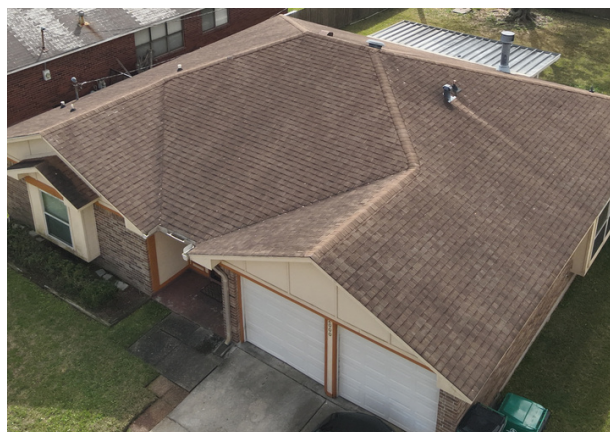
*Front Roof Elevation (Oblique 45°)*

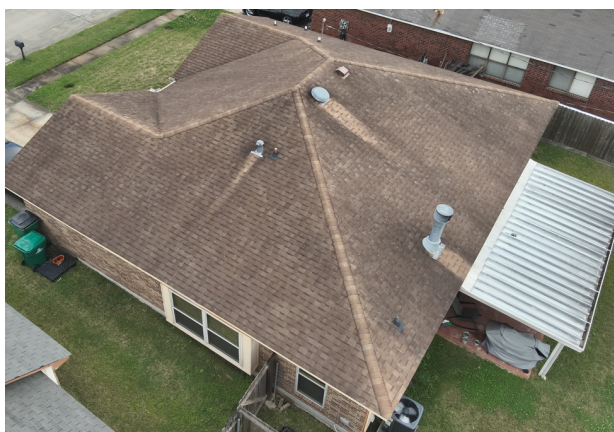
*Rear Roof Elevation (Oblique 45°)*

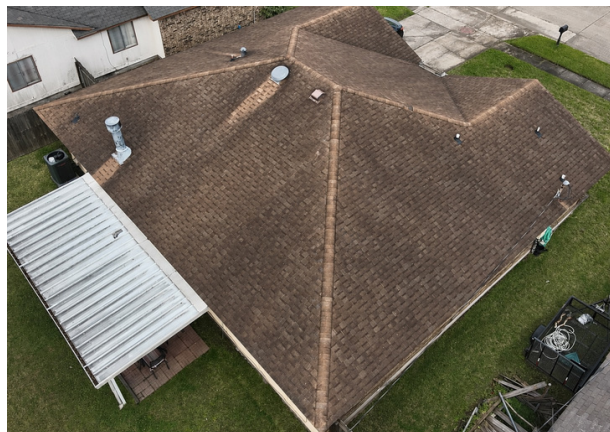
*Right Roof Elevation (Oblique 45°)*

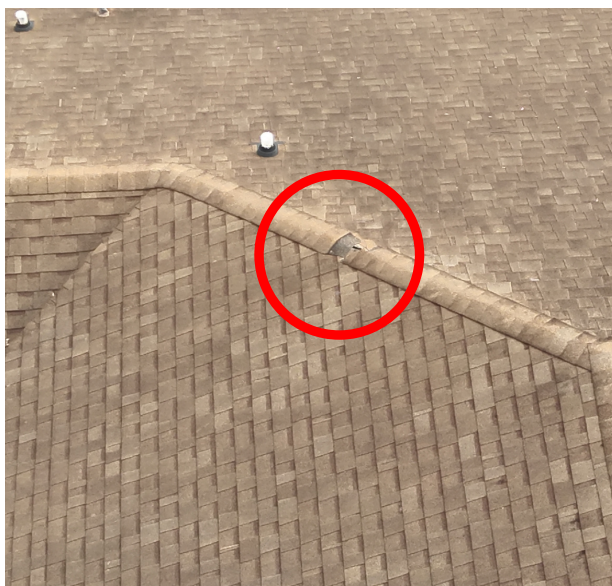
The following photographs document the visible roof surface. An area where roofing shingles appear to be absent was observed during the aerial inspection. No determination is made regarding the cause or extent beyond what is visible in the images

*Overall View of Missing Shingle Area*

Review the documented area with a qualified roofing contractor if the client desires further evaluation of the observed condition.

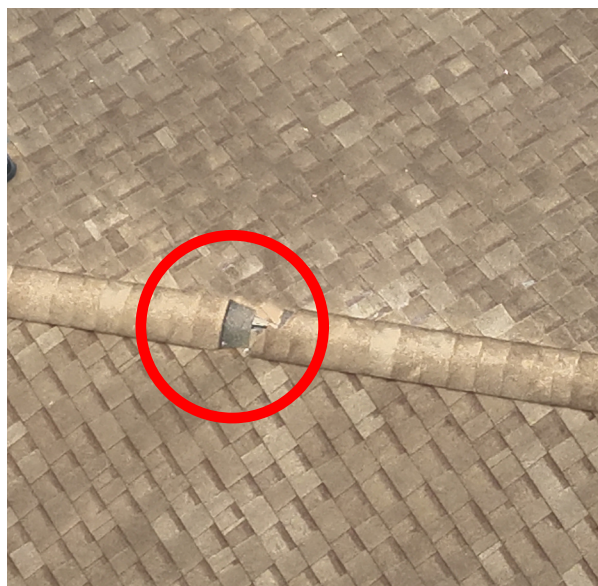
*Close-Up of Missing Shingle Area*

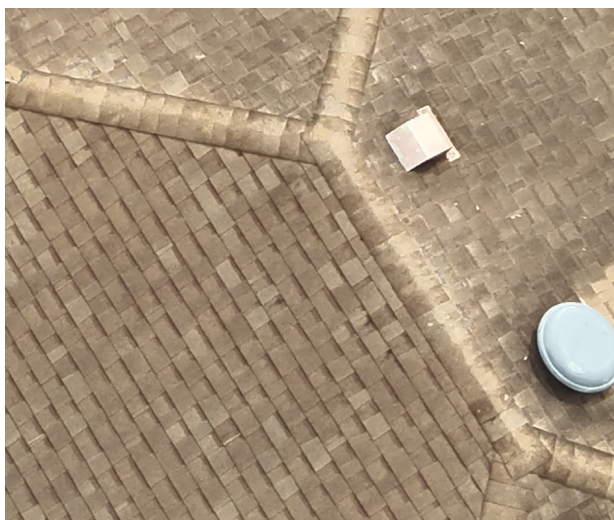
*Plumbing Vent & Roof Surface*

No additional follow-up is recommended for the roof components documented in this section based on the visible conditions observed during the aerial inspection.

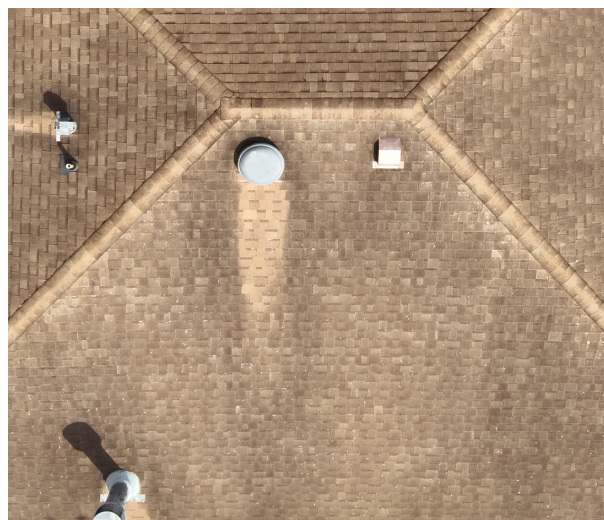
*Roof Vent & Ridge Area*
