Detailed Roof Inspection - Premier Inspection & Media

Sample Property - New Orleans, LA

April 24, 2026

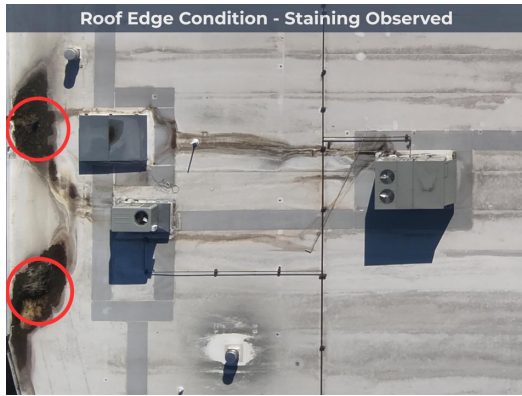
Photo 10

Staining observed along roof edge with additional buildup below. Condition may indicate moisture retention or normal wear. Recommend monitoring.

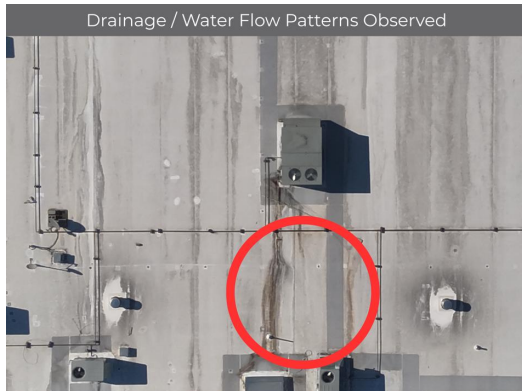
Photo 11

Visible staining patterns indicate consistent water flow across the roof surface. Streaking suggests areas where water travels or may temporarily accumulate. No significant drainage failure was observed; recommend continued monitoring.
